Product Support Bulletin 2005-008

Maintenance of Way ~ Work Equipment Bulletin

SUBJECT: Wing Lift Cylinder Pin Replacement Kit – 660123

MACHINE MODEL(S): Model M2-14 Ballast Regulator/Snow Fighter
Model G2 Ballast Regulator

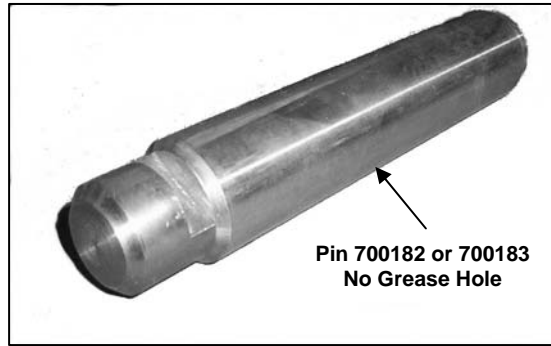
Figure 1

SUMMARY: There have been reports of Wing Lift Cylinder Pins breaking during use. The break normally occurs in the area of the pin grease hole. To solve this problem, new pins have been designed without a grease hole. Grease fittings are added to both the rod-end and cap-end clevises of the Wing Lift Cylinder (p/n 7500-116) to lubricate the pins.

ACTION: The Wing Lift Cylinder Rod End Pin (p/n 700118) should be replaced with the new **Pin (p/n 700183)** and the Cap End Pin (p/n 700118) should be replaced with the new **Pin (p/n 700182)**. The new pin is direct replacement for the original pin. The new pins do not have grease holes. See Figure 1. However, the cylinder must be drilled to accept **Grease Fittings (p/n 3801230)**. See Figure 2. The **Pin Field Replacement Kit (p/n 660123)** includes both Pins, Grease Fittings and clevis drilling instructions. Two kits are required per machine. The kit can be installed in about an hour.
