Product Support Bulletin 2016-002

SUBJECT: Tripp Rear Suspension Arm Mounting Reinforcement Kit

MACHINE MODEL(S): Tripp Models A-D

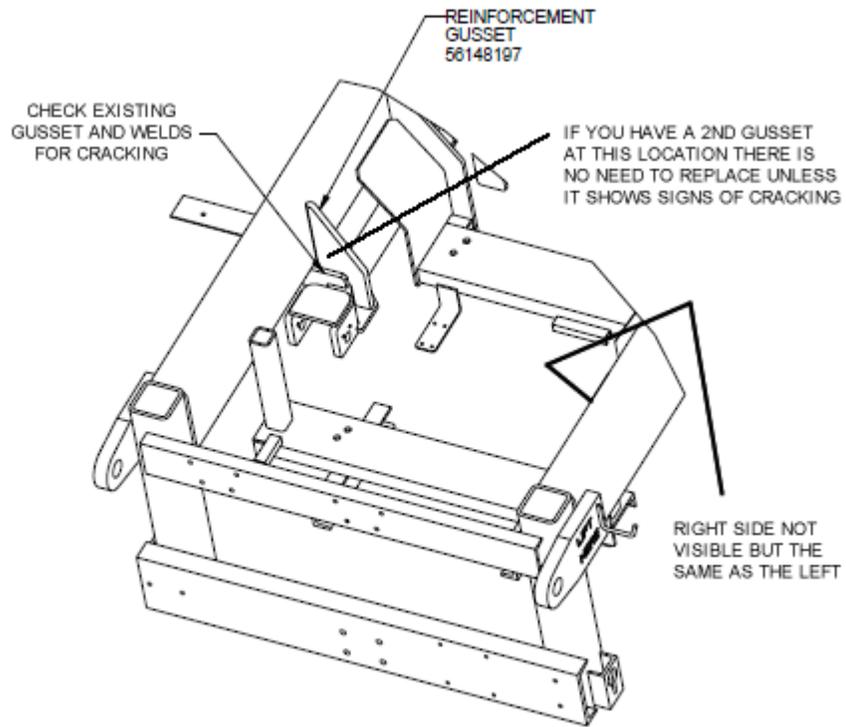
SUMMARY: Some customers with Tripp Machines in the S/N Range listed have reported main frame cracking near the rear suspension arm mounts.

OPERATIONAL IMPACT: If your machine has these cracks, the rear suspension arms could possibly break off during travel or operation of machine.

Figure 1. Rear Arm Inspection Area

Nordco has developed a kit, Part Number 98760127, that reinforces that area of the frame. It is recommended that welding of this kit be done by an AWS Certified Welder.

ACTION: Inspect both Rear Suspension Arm mountings for cracking at existing gusset and welds (See next page for picture showing the left rear mounting inspection area). Pay close attention to the welds at that location. If you spot cracks on the gusset or welds, contact Nordco Parts Department at 1-800-647-1724 to order your kit. Installation instructions are provided in the kit.
