PRODUCT SUPPORT BULLETIN NO. 211

MACHINE: **Auto-Lift S/N 200 through 543 Numbers**

SUBJECT: PROPEL MOTOR CHAIN ADJUSTMENT & MOTOR MOUNTING

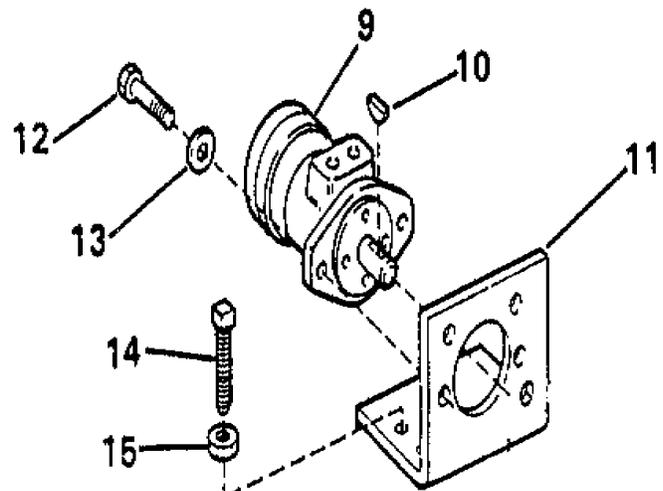
It was difficult to adjust the propel motor chain slack and change out the motor because of the placement and type of bolts used in this application.

1. The 2145 0044 Propulsion Motor Mounting (Item #11 in illustration) has been made 1/2-inch longer to increase wrench clearance.
2. The 2947 193 Square Head Setscrew 1/2-13 x 2 (Item #14) has been replaced by a 2775 321 Hex Head Capscrew 1/2-13 x 2.
3. The 2775 292 Hex Head Capscrew 1/2-13 x 1-1/4 (Item #12) has been replaced by 2783 291 Socket Head Capscrew 1/2-13 x 1-1/4.
