PRODUCT SUPPORT BULLETIN

BULLETIN NO. 288

MACHINE: Model C Spike Driver

SUBJECT: Relocate Hydraulic Tank Pressure Switches

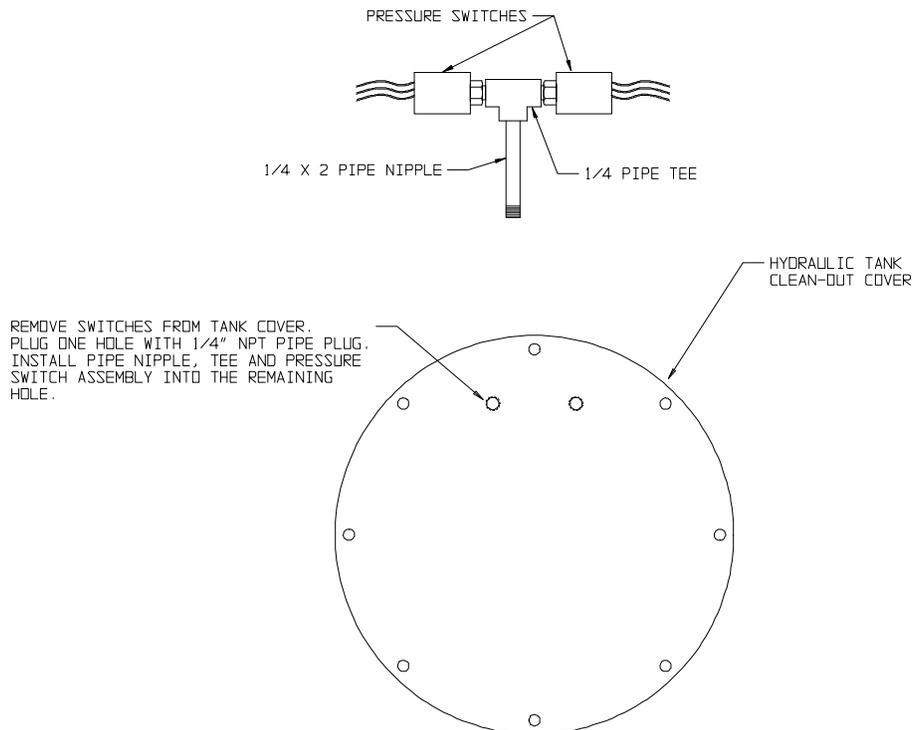
We have had some incidents reported of pressure switch failure due to moisture entering the pressure switches. One source of entry is capillary action through the unused connections of the Packard connectors. A cavity plug, part number 5166784, is available to seal this area. Refer to Product Support Bulletin 279 for details.

Because of the vertical mounting of the pressure switches on the tank, water can also enter the switches by running between the wires and sealant of the switch. To minimize the potential of this happening, the pressure switches may be remounted as shown in the illustration.
