PRODUCT SUPPORT BULLETIN BULLETIN NO. 298

MACHINE: **Model 99C Spike Driver**

SUBJECT: **Float Switch Failures – Part No. 5194901**

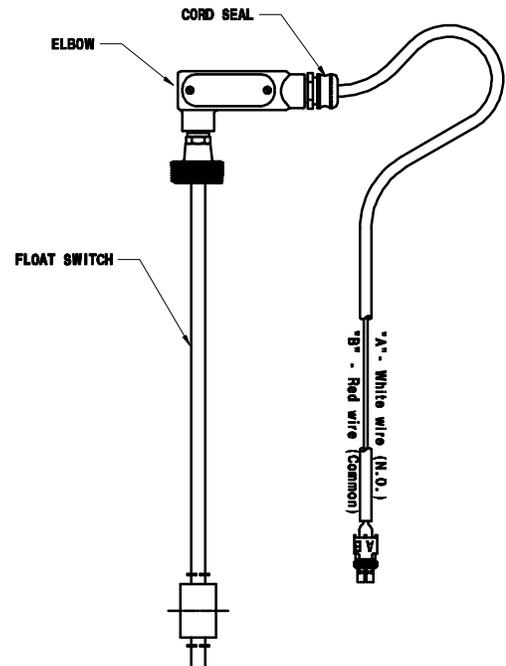
1. Water entering the switch through the wiring at the top of the switch. This problem is being addressed by the addition of a weatherproof elbow and cord seal at the top of the switch. The elbow will prevent water from running down the wires into the switch.
2. Electrical failure due to more current draw than the rated capacity for the switch. A relay is being installed in the pump destroke valve circuit to reduce the electrical load seen by the switch. The relay snaps into the existing mounting track inside the Main Logic Box and wired as shown in Figure 2.
