# Product Support Bulletin 2009-003

## Maintenance of Way ~ Work Equipment Bulletin

**SUBJECT:** Up/Down Cylinder Bushing Added to Workhead Frames – 22133746

**MACHINE MODEL(S):** CX Hammer  
C-CX Hammer Conversions

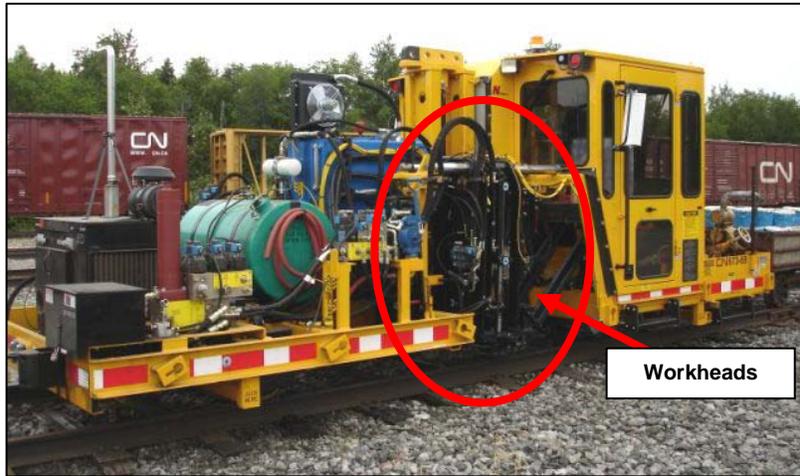
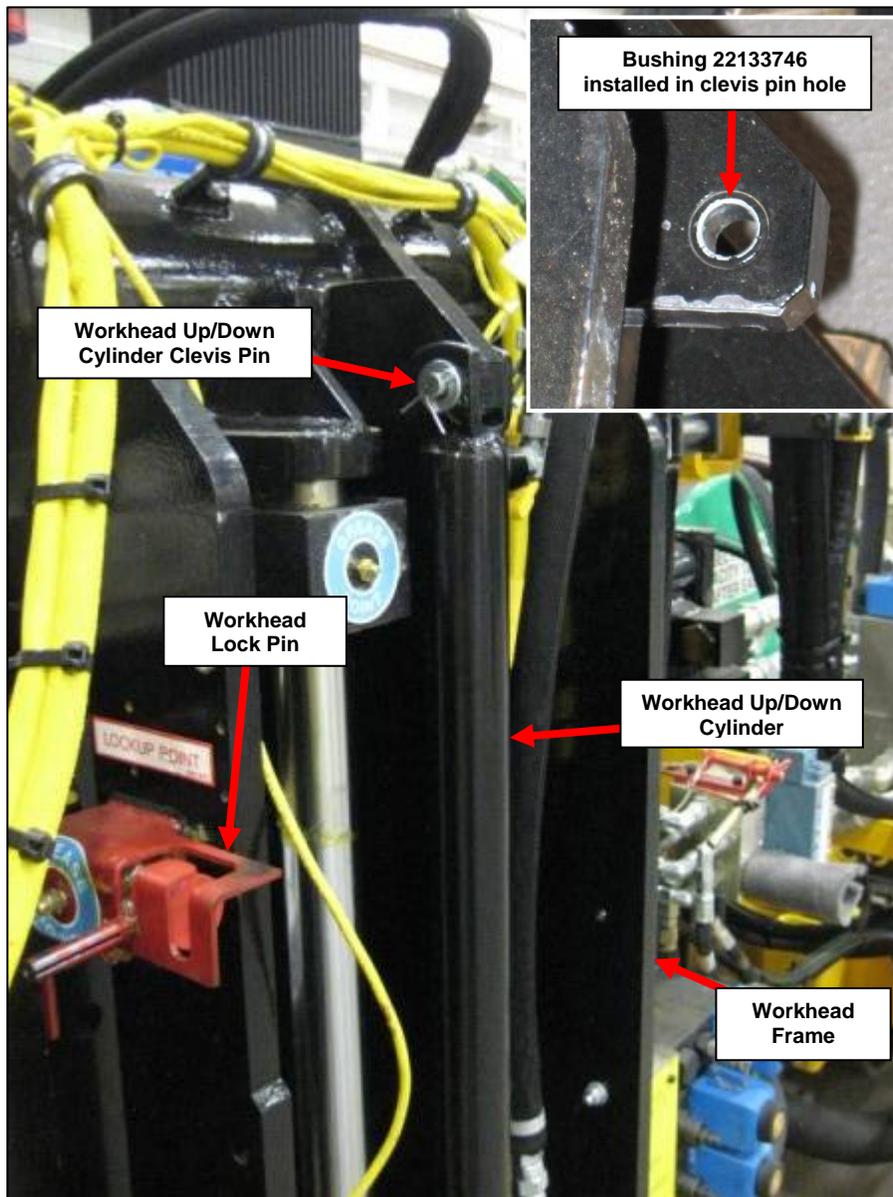
**SUMMARY:** The 22133746 Workhead Frame Bushing is installed in the upper clevis pin hole for the Hammer Up/Down Cylinder to prevent the pin from wearing out the base material of Workhead Frame.

**OPERATIONAL IMPACT:** If the clevis pin hole is worn, the Spiking Gun may not come up to its full height. This could prevent the Lockup Pin from engaging or in extreme cases could prevent the feeding of spikes into the spike jaws.

**ACTION:** All machines with serial numbers 410867 and higher have the bushing installed. If bushing replacement is necessary, the bushing may be pressed out and a new bushing pressed into place. See Figure 1 on Page 2. The following replacement Workhead Frames are also affected by this change:

Due to the fine tolerance involved in boring the bushing hole, field installation of the bushing into a worn Workhead Frame or one which does not have the correct bore size for the bushing is not recommended.
