PRODUCT SUPPORT BULLETIN BULLETIN NO. 367

MACHINE: Model C, 99C and 99C-03 Spike Driver

SUBJECT: Rail Clamp Cylinder Rod Interference with Pivot Bracket

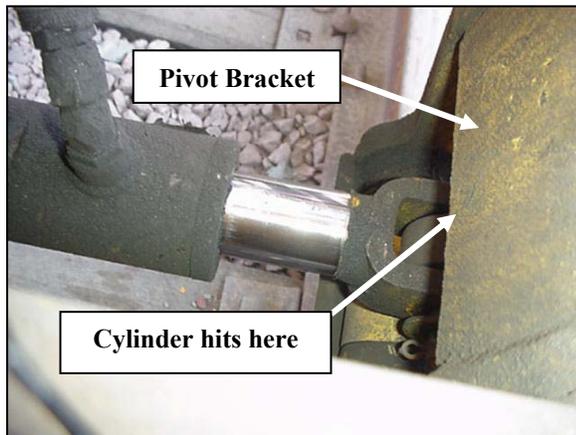
Figure 1

On some machines, the Clamp Cylinder Pivot Bracket may interfere with the Clamp Cylinder Rod during cylinder operation if the bushings are worn. See **Figure 1**. This interference can nick the cylinder rod and can cause a premature failure of the Cylinder Rod Seal.
