PRODUCT SUPPORT

BULLETIN NO. 256

MACHINE: **ALL MACHINES WITH
ISRINGHAUSEN 6000 SEATS**

SUBJECT: **WELDMENT PROBLEMS**

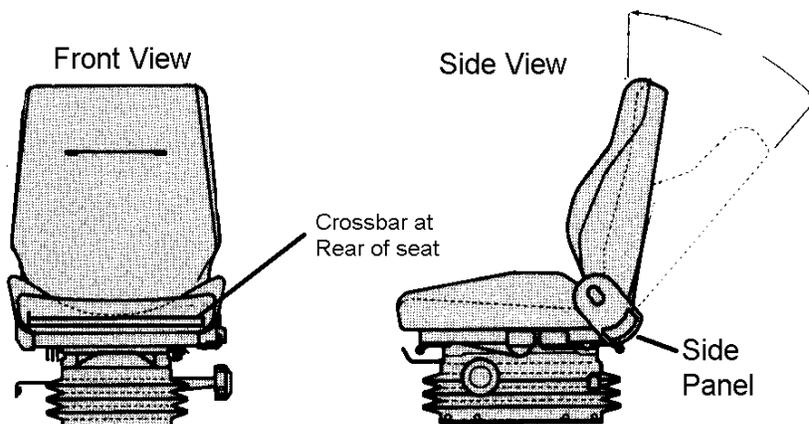
There have been some instances where unusual force against the seat back of the ISRI 6000 seat has caused backrest support weldments to break away from the seat frame. This may cause the position and locking of the seat back to become unstable.

The crossbar that runs parallel to the seat back between the two plastic side plates at the rear of the seat (see Figure) has tack welds holding it to the frame. This crossbar controls the locking and position of the seat back. If an unusual force hits the backrest from behind, these tack welds may become unstable and you may not have your seat locked in ANY position.

To prevent this problem from occurring, additional welds must be made to the tube and seat frame. Please remember to remove all the boards from the Logic Box **BEFORE WELDING** on your machine.
