## PRODUCT SUPPORT BULLETIN BULLETIN NO. 297

MACHINE: **Model C Spike Driver**

SUBJECT: **Jaw Mounting Guide Rod Breakage – Part No. 14382490**

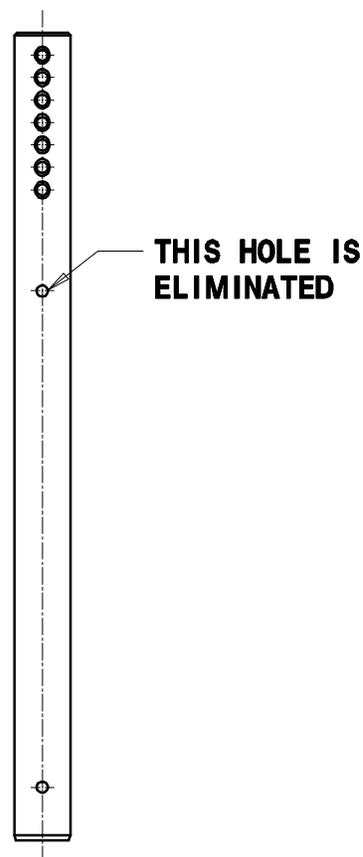
There have been several instances of guide rod breakage on the Model C. It has been determined that the guide rods are breaking through the hole in the guide rod located 5.75" from the top of the rod. This breakage occurs when a side load is applied to the guide rod such as when a spike bends while being driven.

To solve this problem, the hole has been eliminated. Any new orders for Guide Rod 14382490 placed after November 20, 1999 will not have this hole.
