Product Support Bulletin 2009-001

Maintenance of Way ~ Work Equipment Bulletin

SUBJECT: Lubricated Rail Lifter Clamp Roller Pin – 19552002

MACHINE MODEL(S): TRIPP – Tie Exchanger

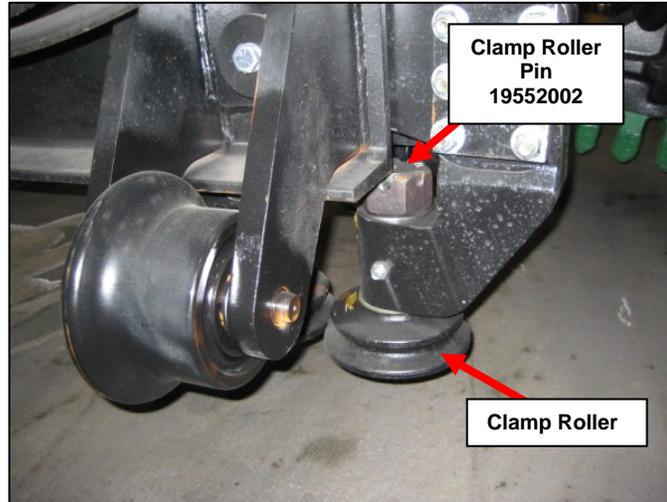
Figure 1
Rail Lifter Clamp Roller Assembly

SUMMARY: The Clamp Roller Pin turns in a self-lubricating bushing and does not require lubrication; however, some customers wanted the ability to provide additional lubrication to the pin and bushing. See Figure 1 on Page 2. The Clamp Roller Pin has been changed to add a grease hole to lubricate the pin and bushing. The pin has a threaded hole in the end to accept a 1/8" NPT grease fitting, p/n 3801052 (not included). See Figure 3 and 4 on Page 2.

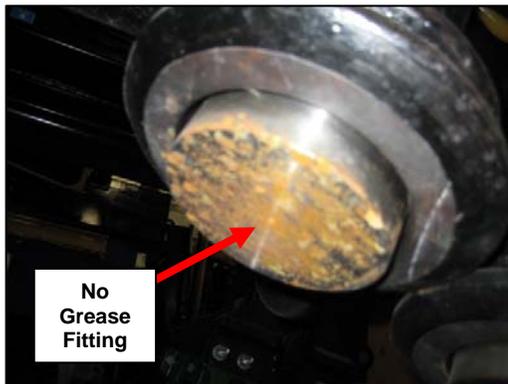
Figure 2
Bottom of Original 19552002
Roller Pin

ACTION: The lubricated Clamp Roller Pin is directly interchangeable with the non-lubricated pin. However, the 3801052 Grease Fitting must be purchased separately. The non-lubricated Clamp Roller Pin is shown in Figure 2 on Page 2. Lubricated Pins will be furnished on all orders for replacement Clamp Roller Pins.

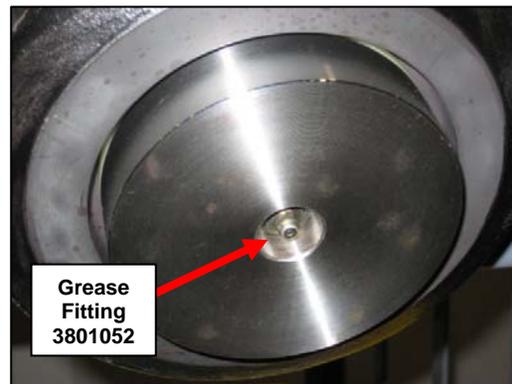
Figure 3
Bottom of New 19552002 Roller Pin with
3801052 Grease Fitting Installed
(Grease Fitting sold separately)

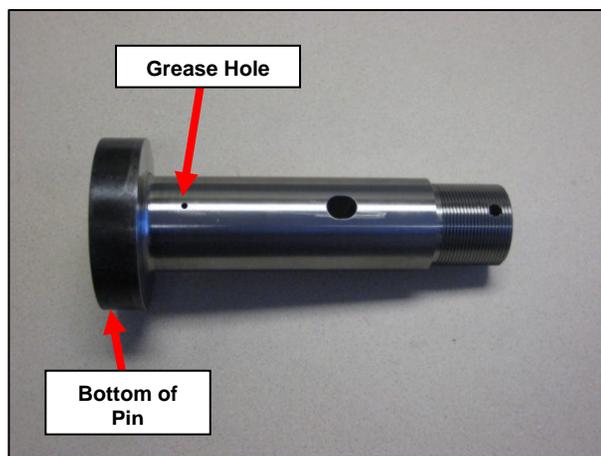
Figure 4
New Greasable 19552002 Roller Pin
