This Booklet

Nordco Rail Services and Inspection Technologies (NRS&IT), a global provider of rail flaw testing equipment and services, is pleased to offer this flaw identification handbook as a service to our current and future customers.

It is designed to help track safety and maintenance-of-way personnel understand what causes different rail flaw types, how flaw types appear, and how quickly flaws can develop. In addition, there is a full glossary of rail and NDT terms.

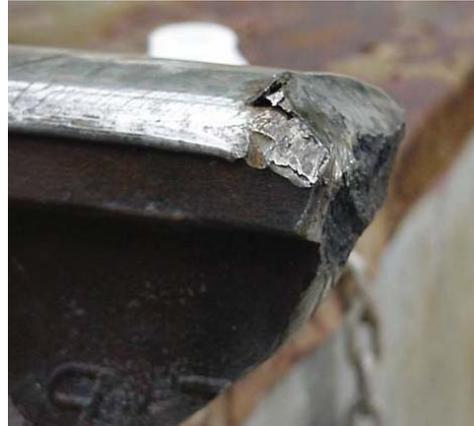
Rail batter

Impact batter from wheels

Batter is significant rail-end damage or a smooth polished fracture face. The two significant types of rail batter are impact batter and friction batter. Impact batter results from a rail break, exposing the fracture face to wheel impact from rolling stock. Friction batter results from sufficient rail section separation allowing the two fracture faces to make contact under load. Both types of batter can obliterate the matching fracture faces, preventing identification of underlying fatigue conditions.

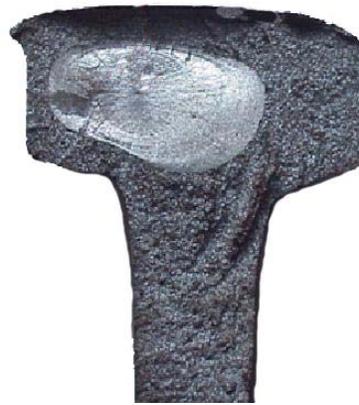
Transverse Fissure

Identification - The distinguishing features are the crystalline center or nucleus and the nearly smooth surface of development that surrounds it. A transverse fissure must show a nucleus that is more than 1/4 inch from any surface of the head. Separation is substantial and at a right angle to the running surface. The fissure completely surrounds the nucleus and shows growth originating from the nucleus.

Appearance - A transverse fissure cannot be positively identified until the rail is broken for further inspection.

Detection - Transverse fissures can be detected by seventy degree (70) transducer beams.

Definition - A transverse fissure is a progressive crosswise fracture originating from a nucleus located inside the head, spreading outward as a smooth, bright or dark, round or oval surface substantially at a right angle to the length of the rail. Transverse fissures come from the manufacturing process and are found predominately in non control-cooled rail from the 1930s. However, it can develop in modern high-chrome rail from a hydrogen imperfection.

Origin - The origin is an imperfection in the steel, such as a shatter crack or a minute inclusion. Wheel impact or bending stresses frequently start the growth of a transverse separation around the originating imperfection.

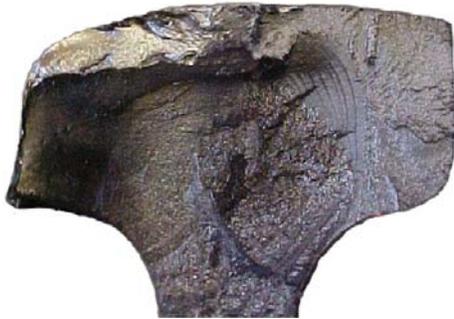
Compound Fissure

Origin - The fissure usually starts as a horizontal separation from an internal longitudinal seam, segregation, or inclusion (from the manufacturing process). It develops longitudinally for some distance, then turns (upwards, downwards, or both) in relation to the transverse plane.

Identification - Both longitudinal and transverse separations are usually exposed. The longitudinal separation may be as short as 1/8 inch, appearing only as a displacement between two transverse planes; it is usually parallel to the running surface. The transverse separation often resembles a transverse fissure except that there is no nucleus.

Definition - A compound fissure is a progressive fracture originating in a horizontal split head, which then turns up or down in the head as a smooth, bright or dark surface, progressing until it is substantially at a right angle to the length of the rail.

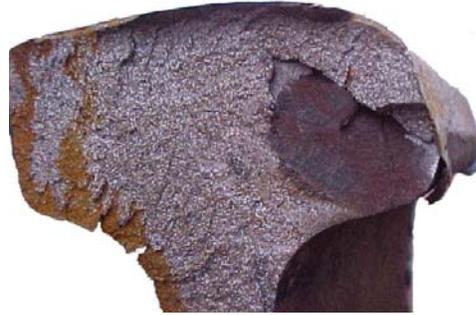
Detail Fracture Originating
from a Visible Shell

Identification - The longitudinal separation and the streak/seam where it originated is not often visible. The transverse component resembles a transverse fissure except that no nucleus is present and the transverse separation spreads from a longitudinal separation in the upper gage corner.

Definition - A detail fracture from shelling, whether visible or not, is a progressive fracture at or near the surface of the rail head. Do not confuse these fractures with transverse fissures, compound fissures, or other defects with internal origins.

Origin - The origin is usually a longitudinal seam or streak near the running surface on the gage side (field side if rail was turned). The separation progresses longitudinally (not as a true horizontal crack), at an angle related to the amount of rail wear on the gage corner. The crack then turns downward and inward to form a transverse separation.

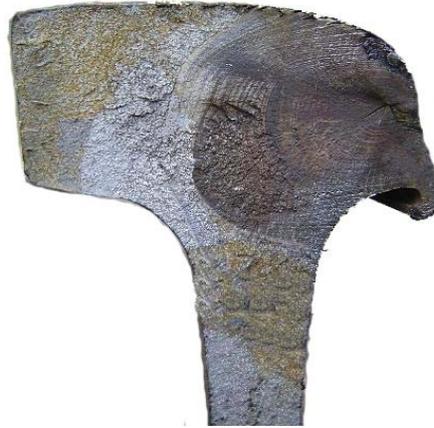
Reverse Detail Fracture

Identification - A reverse detail fracture shows a transverse separation which starts at the lower gage corner and spreads in crescent-shaped rings radiating from the point of origin.

Definition - The reverse detail fracture is a progressive fracture, starting at either bottom corner of the gage side of the rail head, spreading transversely through the head.

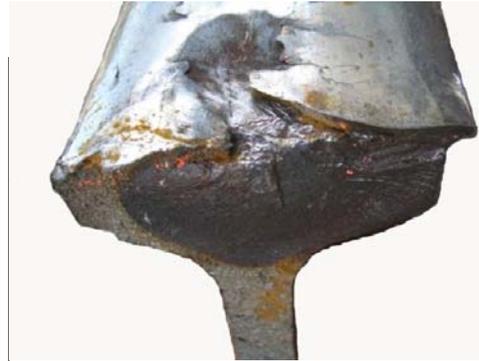
Identification - An engine burn fracture shows the surface burn. The transverse separation has no nucleus and may exist in any of the three planes. The horizontal separation starts at the running surface and slants downward.

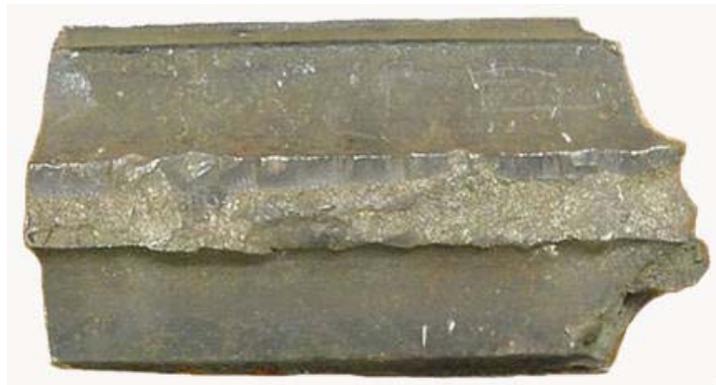
Head and web separation showing progression into the web.

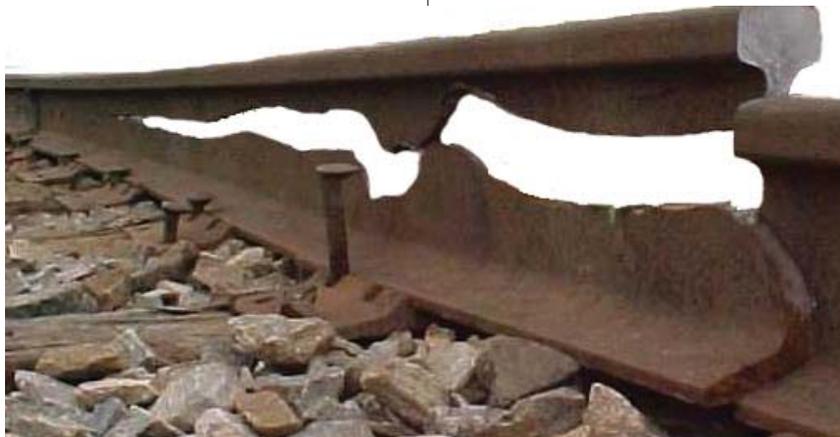
Web failure resulting from high residual stress.

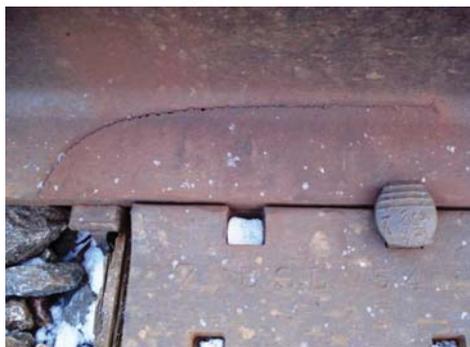
Broken Base

Definition - A broken base is a progressive fracture in the base of the rail, with a vertical separation or split. A broken base is normally confined within the flange area of the rail base and is usually an oval-shaped break called a half-moon break.

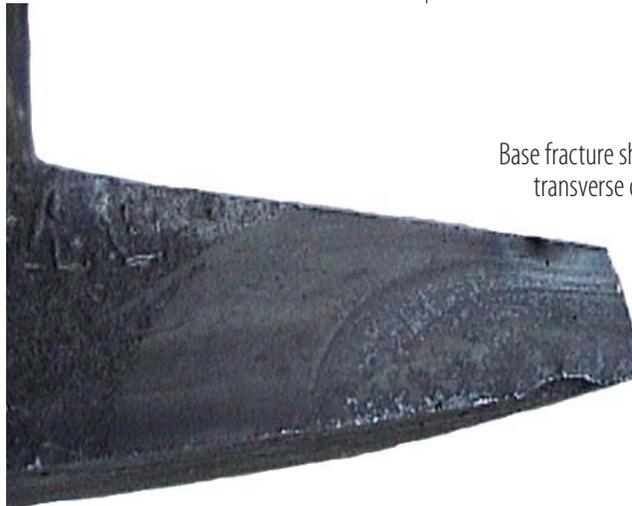
Base fracture showing nick with transverse development

Appearance - Base fractures are visible as hairline cracks for the extent of the progressive development into the rail. However, these defects are seldom found visually since a complete rupture usually occurs from a relatively small defect.

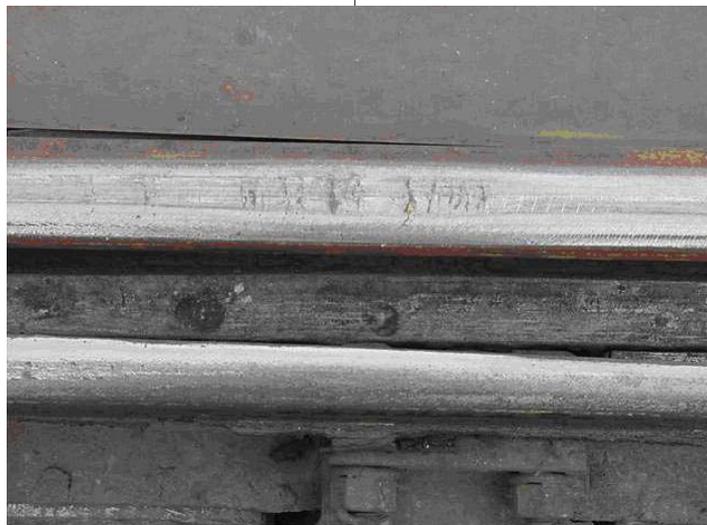
Thermal cracks on burned stock rail

- A rough spot - round or oval - with slivers (from metal flow where metal has flattened or separated just below the surface) on the tread of the running surface, where metal was displaced and solidified.
- Thermal tracks originating at the rough spot.

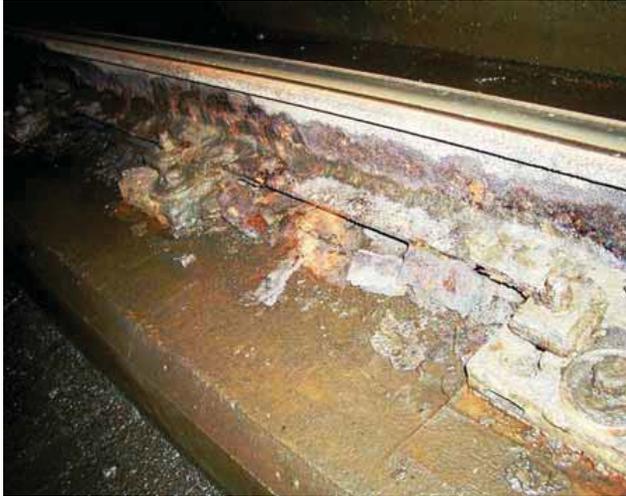
Corrosion on rail, fastening systems, and plates

Definition - Corrosion is the decaying or corroding of the metal on the web or base of the rail which results in irregular pits or cavities.

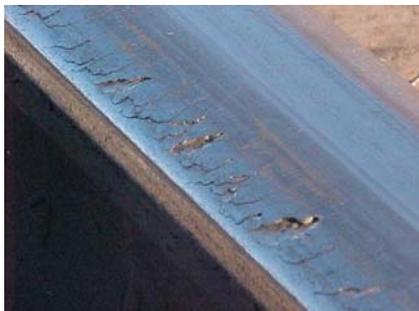
Gauge side head checking and flaking

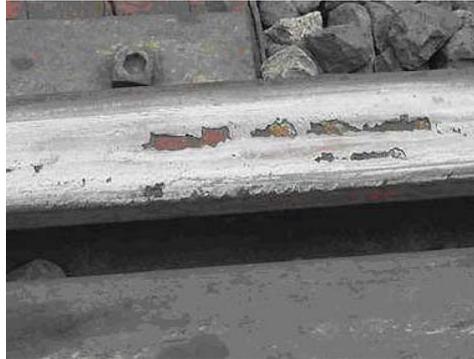
Flattened rail head showing displacement of parent metal (spalling)

Definition - Spalling is generally referred to as the displacement of parent metal from the rail head.

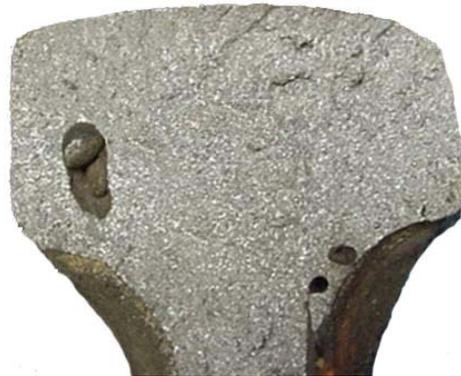
Thermite weld with slag entrapment

Origin - Defective field welds are caused by slag entrapments, inclusions, porosity, or stress risers in the weld upset area.

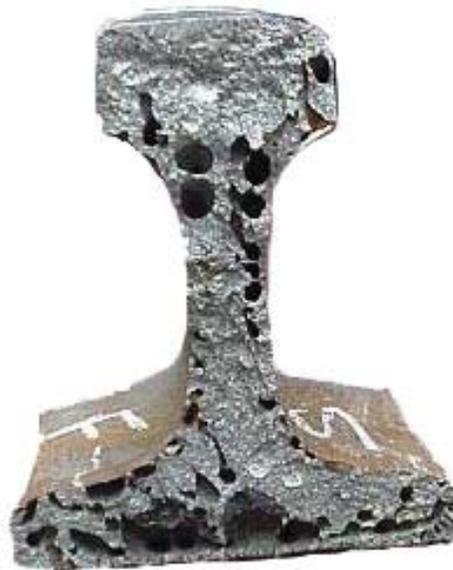
Thermite weld showing severe porosity

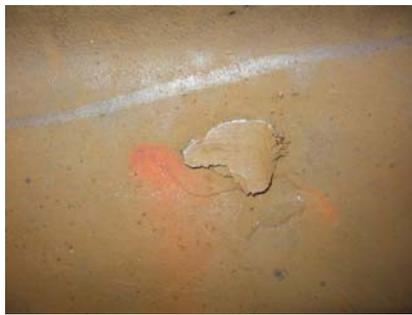
Definition - A detail fracture from a welded bond connection is a progressive transverse defect which develops and expands from the point on the rail head where a head bond is attached by welding.

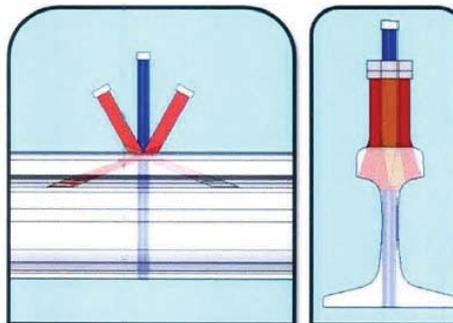
70 degree & 0 (zero) degree beams - this combination of beam angles captures the following types of defects:

- Horizontal cracks in the rail head
