PRODUCT SUPPORT BULLETIN BULLETIN NO. 315

MACHINE: **Auto-Lift**

SUBJECT: **Propel Switch Kit – 98790019**

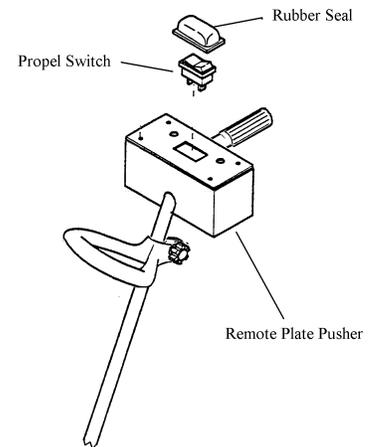
There have been some instances of the Propel Switch, p/n 5125599, on these machines sticking in the “ON” position. If the machine is in the Single Side Operation Mode, this could cause the machine to propel unexpectedly. These switches are mounted on both the Remote Plate Pusher Assembly and the Left and Right Hand Operator’s Control Boxes mounted on the frame of the machine.

This problem is caused by 2 factors. First, if the rubber seal, p/n 67920020 over the switch becomes damaged, the boot can wedge under the rocker of the switch causing it to jam in the “ON” position. To eliminate this possibility, **NORDCO recommends that this seal be removed.** Because the switch is sealed internally, this will not cause a problem with the switch operation.

**Screw Mounted Switch
5125426
(supplied in kit 98790019)**

**Original Bezel Mounted Switch
5125599**

Second, the current switch is a “bezel mount” style switch. There have been some cases of the switch becoming twisted in the mounting hole and causing the switch to become jammed in the “ON” position. To eliminate these possibilities, the current Propel Switch will be replaced by **Propel Switch Kit, p/n 98790019.** This kit includes a **screw mounted Propel Switch, p/n 5125426, mounting hardware and instructions.** Two mounting holes must be drilled in the Remote Plate Pusher Assembly or Operators Control Box on the machine to mount this new switch.

Both switches will be available only until current inventory of the 5125599 switch is exhausted. After that, only the 98790019 kit will be shipped.
