## PRODUCT SUPPORT BULLETIN BULLETIN NO. 365

MACHINE: **Model C Spike Driver**

SUBJECT: **Bulk Loader Auger Reinforcement Kit – 98410147**

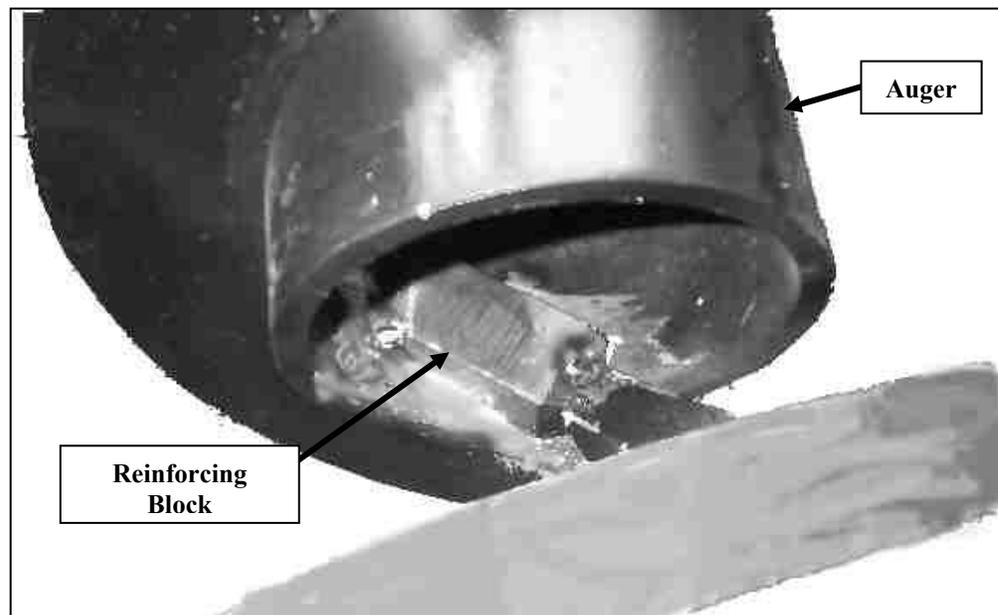
Some of the Bulk Loader Augers, **p/n 26700010**, have been experiencing breakage problems in the area where the auger flights meet the drive hub. This area has now been reinforced with a steel block as shown in Figure 1.

An **Auger Reinforcing Kit, p/n 98410147** to add this reinforcing gusset has been developed and is now available. The kit includes the **Reinforcing Block, p/n 18221730**, and installation instructions.

Installation requires the removal of the auger from the bin. A hoist is required to remove the auger. Additionally, the weld area must be pre-heated to 400-500°F before welding. Total repair time should be 3-4 hours.
