Product Support Bulletin 2009-005

Maintenance of Way ~ Work Equipment Bulletin

SUBJECT: Dust Hood Bumper Pad Material Change – 52890001

**MACHINE
MODEL(S):** CX Hammer

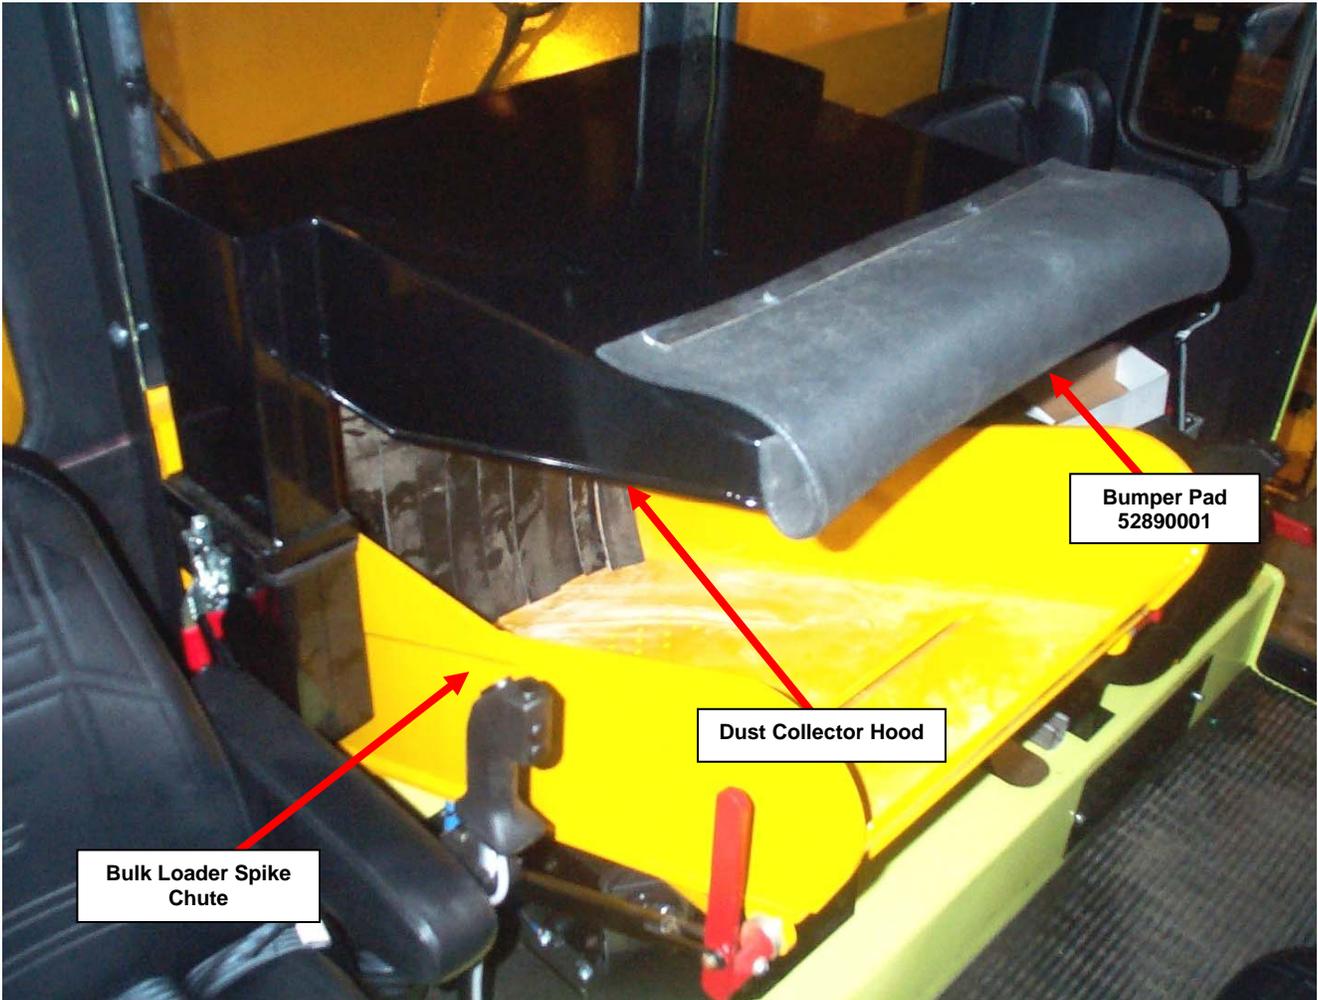
Figure 1
Bulk Loader Dust Hood and Bumper Pad

SUMMARY: The 52890001 Dust Hood Bumper Pad is mounted to the end of the Dust Hood in the Operator's Cab to protect the operator from coming into contact with the steel edge of the Dust Hood. See Figure 1 on Page 2. It was originally made of gum rubber. The material has been changed to reinforced neoprene which will increase the service life of the pad.

**OPERATIONAL
IMPACT:** If the Bumper Pad is damaged, the steel end of dust collector is exposed. Possible injury to the operator could result from contact with the steel edge of the Dust Hood.

ACTION: All Dust Hood Bumper Pads should be inspected and if the pad is damaged, it should be replaced with a new pad. To order new pads, contact the Nordco Parts Department at 1-800-647-1724. All new pads are made from reinforced neoprene.
